CITY OF BOSTON
BOSTON, MASSACHUSETTS

REPORT
OF
INVESTIGATION OF COLLAPSE
AT
HOTEL VENDOME

AUGUST, 1972

MAIN
CHAS. T. MAIN, INC.
Engineers

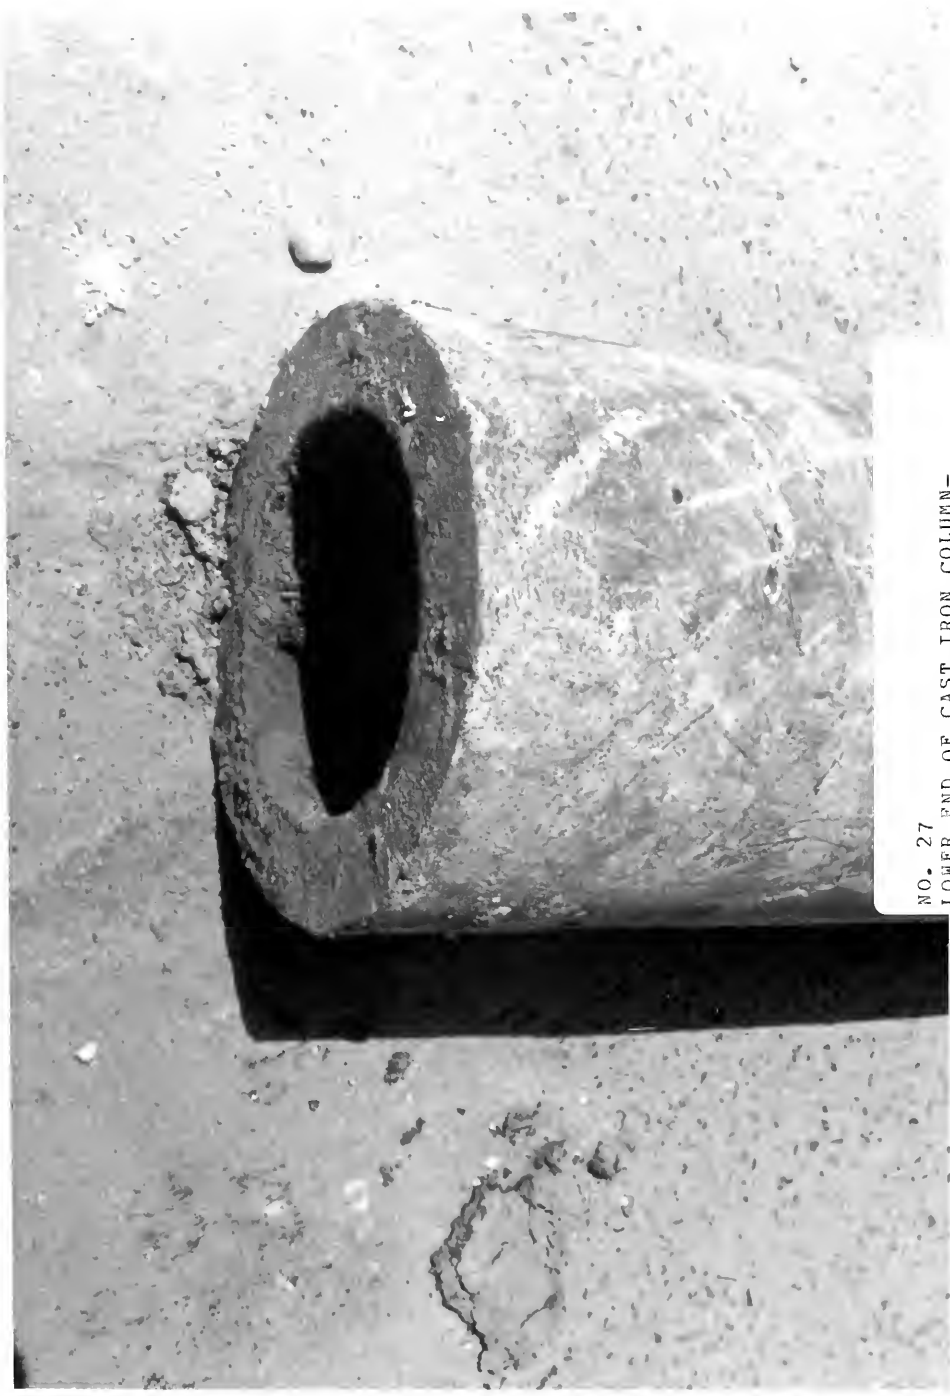
NO. 27
LOWER END OF CAST IRON COLUMN-
NOTE ABSENCE OF CONNECTING
LUGS, CLIPS ETC.

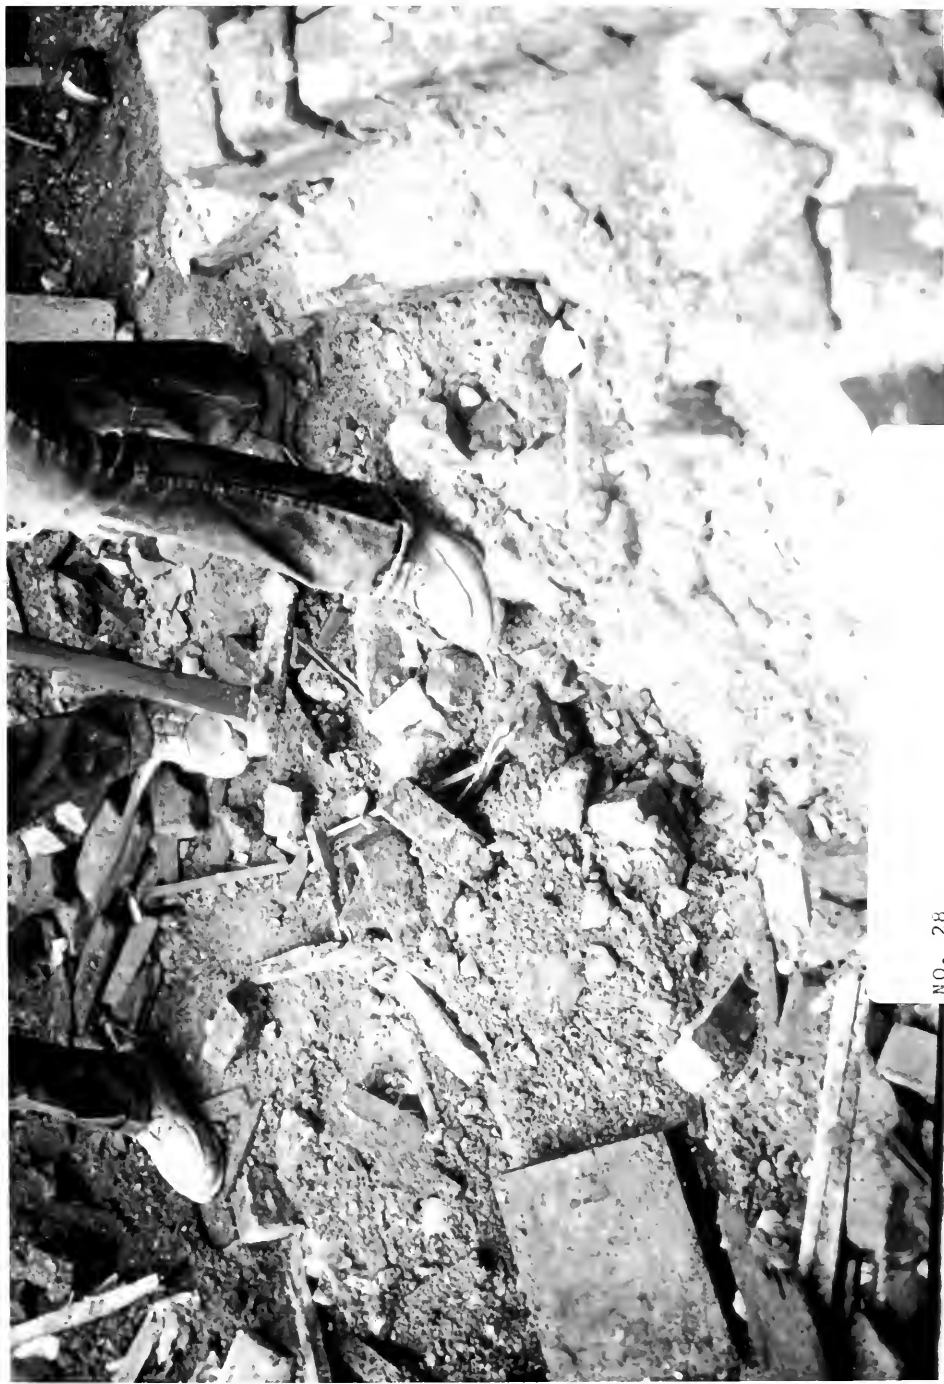
NO. 28

2:45 P.M. The column base plate (12" x 12" x 2") was found resting on the basement floor at a point 4'-6" due south of its original position. There was no debris under the plate; there were no lugs, socket, or bolts to hold the plate and column together.

COLUMN BASE PLATE AS FOUND
RESTING ON BASEMENT FLOOR

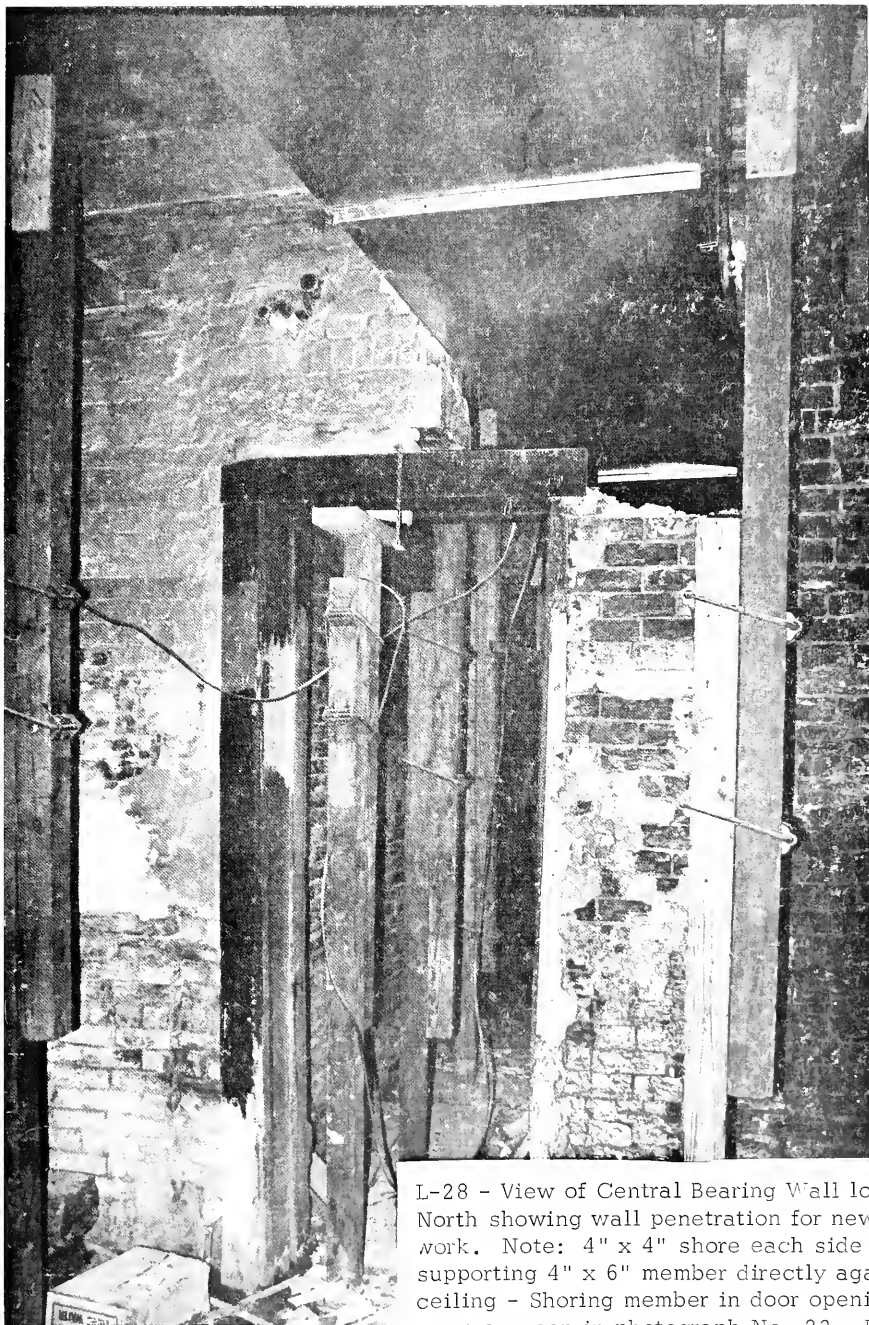
L-28 - View of Central Bearing Wall looking North showing wall penetration for new duct-work. Note: 4" x 4" shore each side of duct, supporting 4" x 6" member directly against ceiling - Shoring member in door opening is same as seen in photograph No. 23. Photograph taken by LeMessurier Associates in 1971.

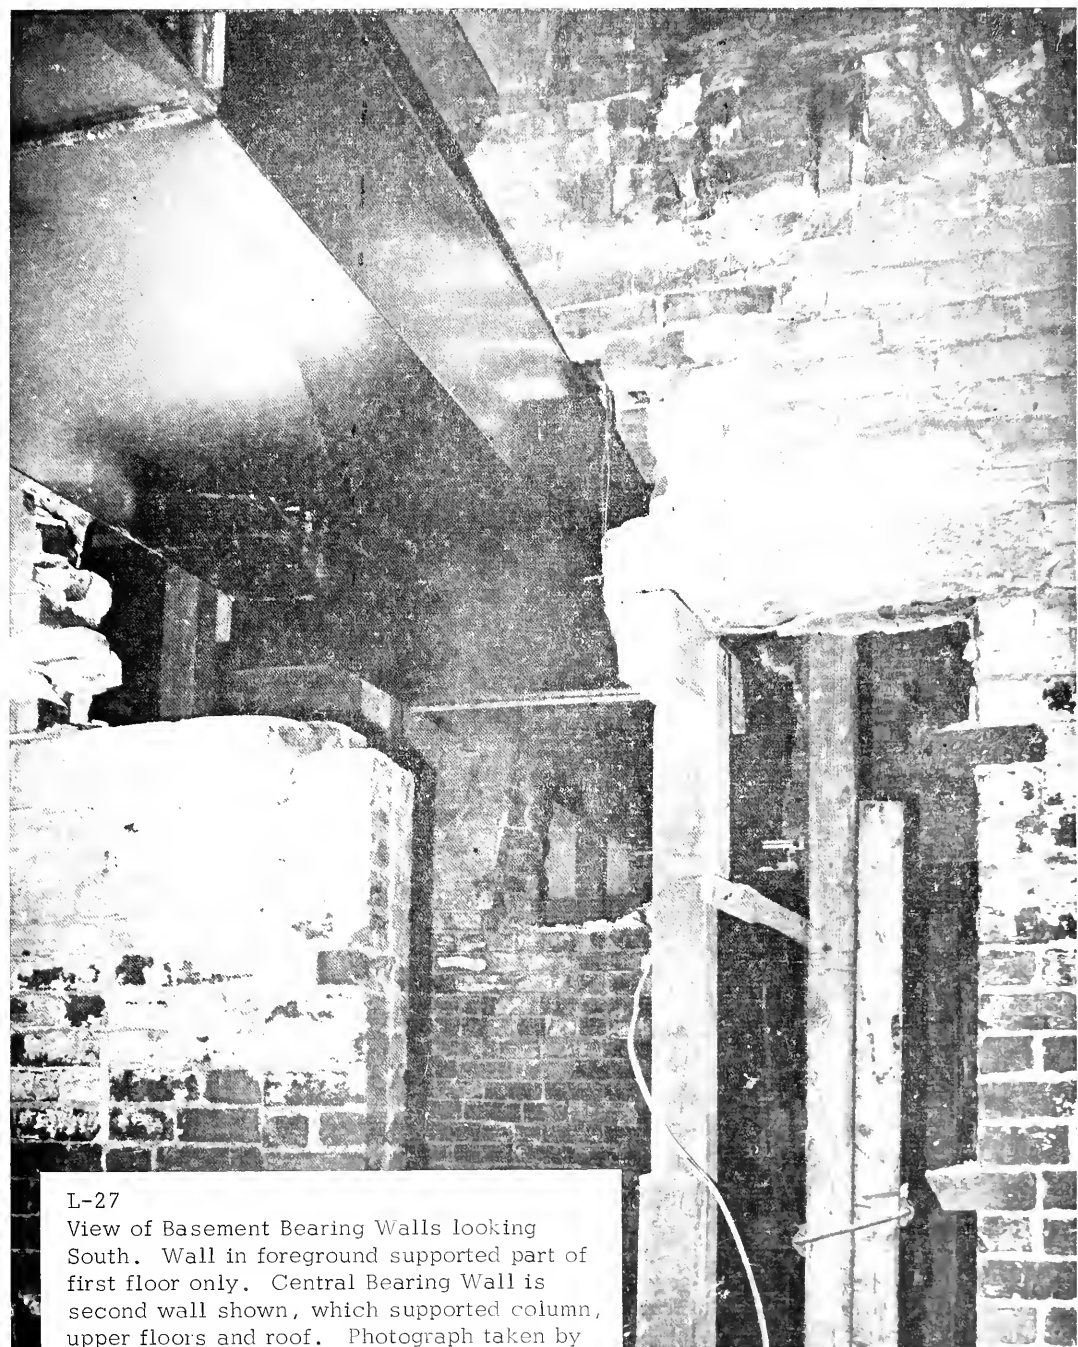
L-27

View of Basement Bearing Walls looking South. Wall in foreground supported part of first floor only. Central Bearing Wall is second wall shown, which supported column, upper floors and roof. Photograph taken by LeMessurier Associates in 1971.
